Assessment of Dam Safety of Coal Combustion Surface Impoundments

Indianapolis Power & Light Company

Petersburg Generating Station

Draft Report

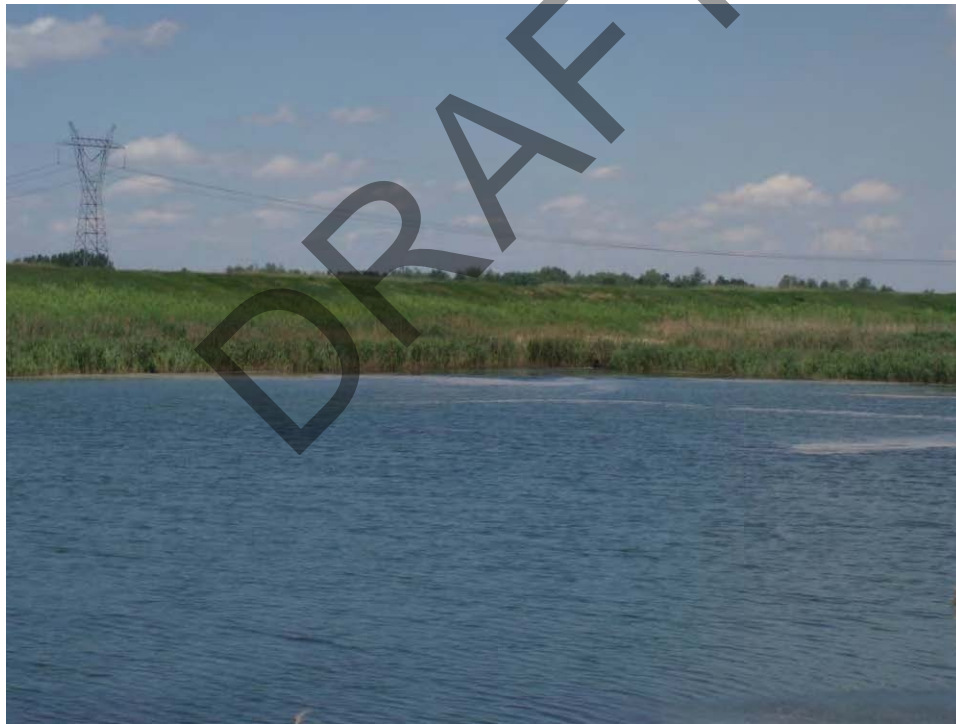
42. Overview of Pond A – Discharge, looking northeast at inlet pipes from Pond A.

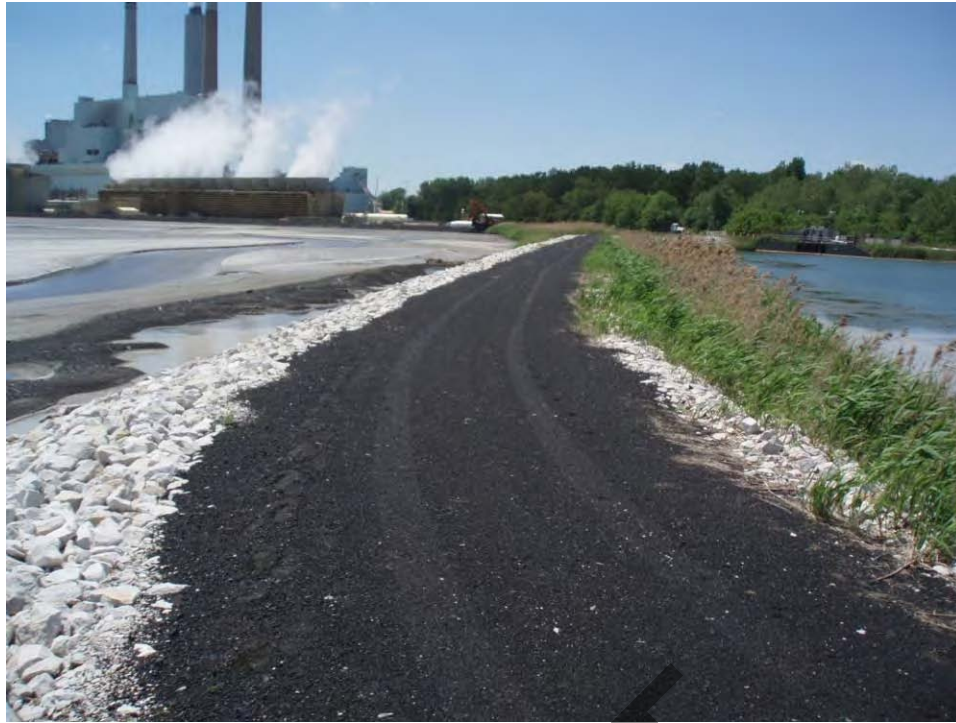
43. Crest of divider embankment between Pond A and Pond A – Discharge, looking southwest.

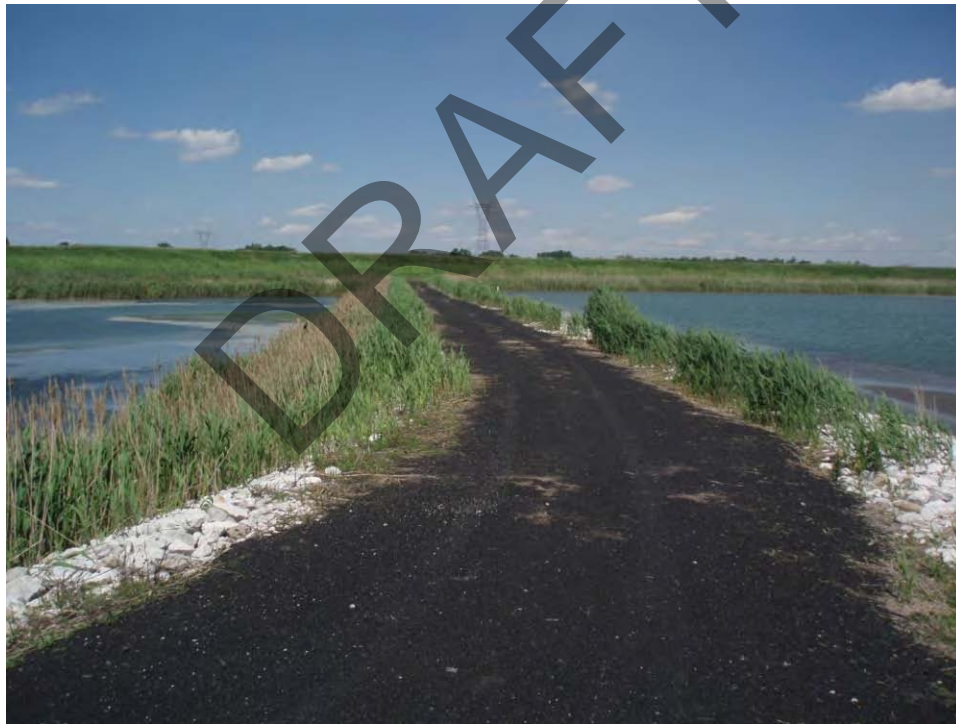
44. Crest of divider embankment between Pond A and Pond A – Discharge, looking northeast.

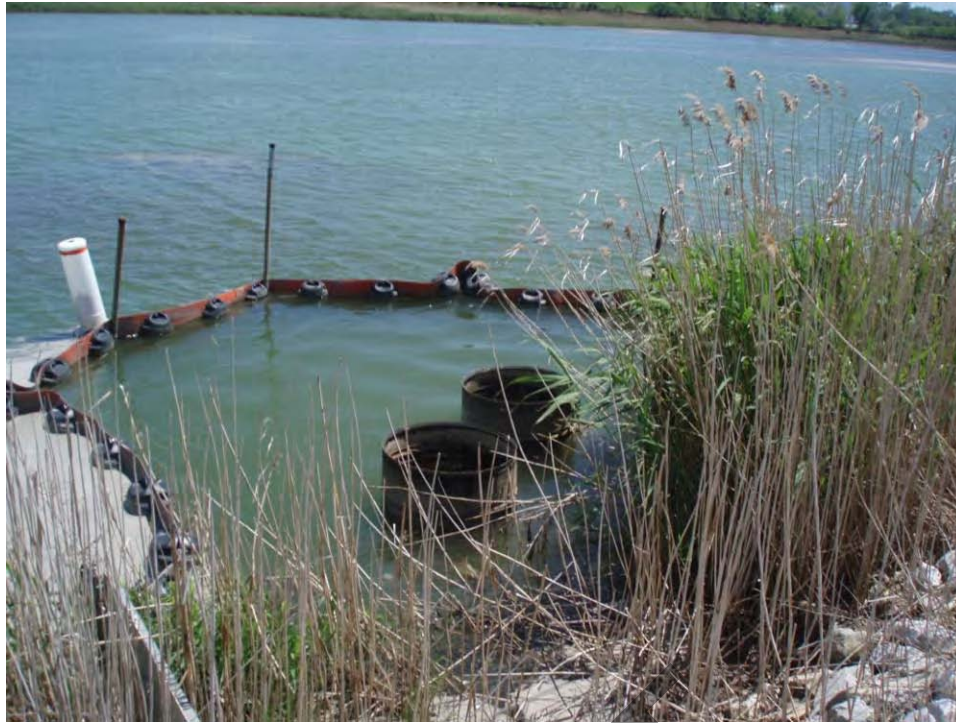
45. Inlet of two (2) 36-inch-diameter CM pipes from Pond A to Pond A - Discharge. Note pipes have T's at inlets and the floating boom to reduce the potential for surface debris from clogging pipes.

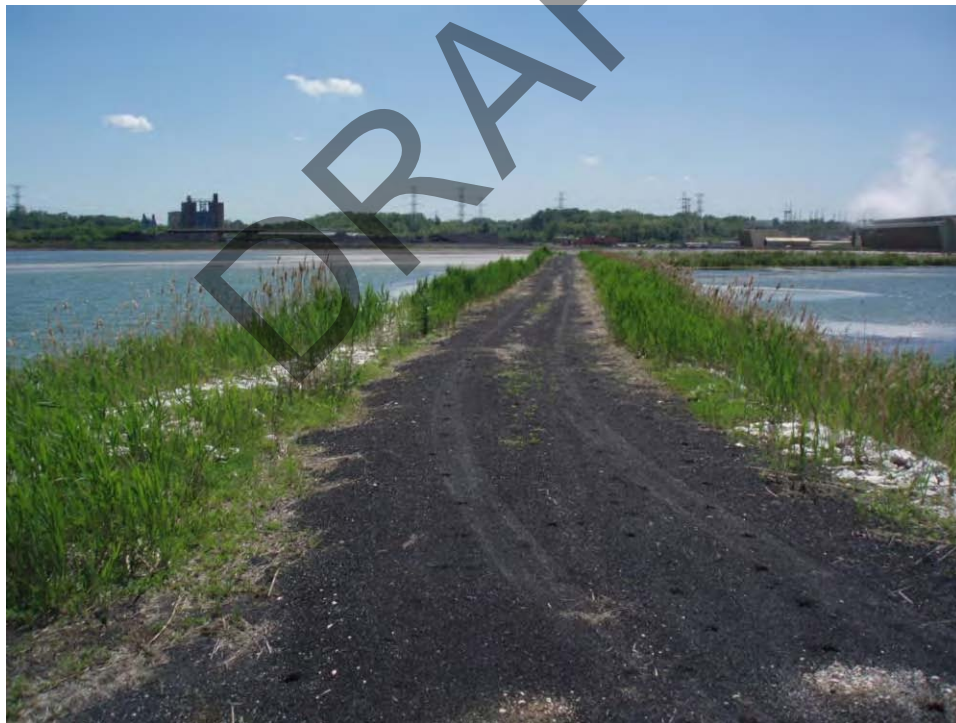
46. Crest of divider embankment between Pond A and Pond A - Discharge, looking southwest.

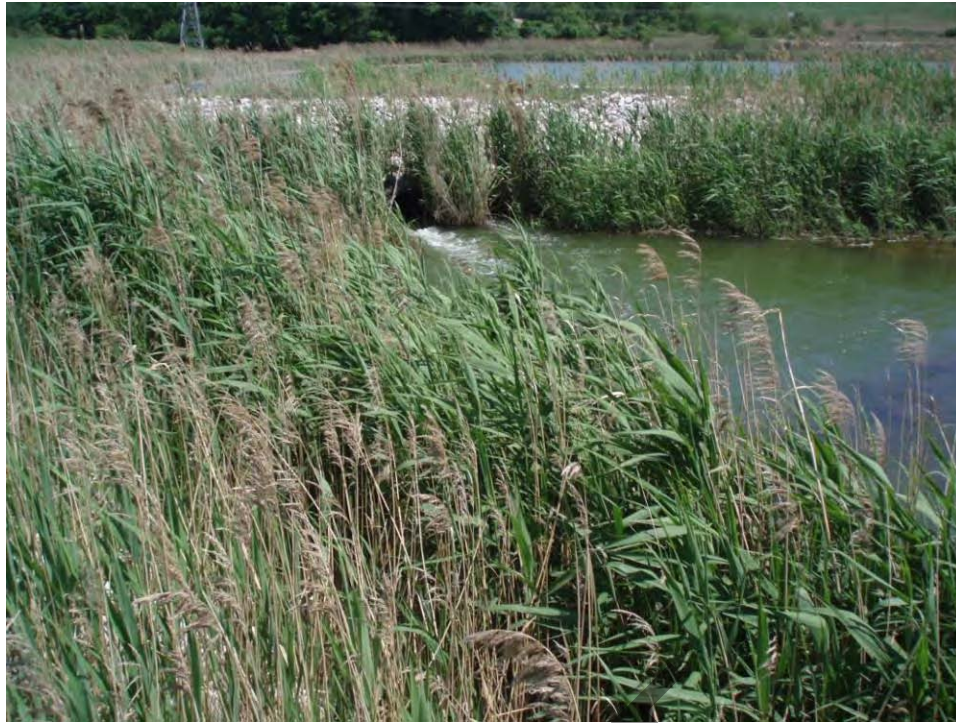
47. Outlet of two (2) 36-inch-diameter CMP outlet pipes from Pond A to Pond A – Discharge.

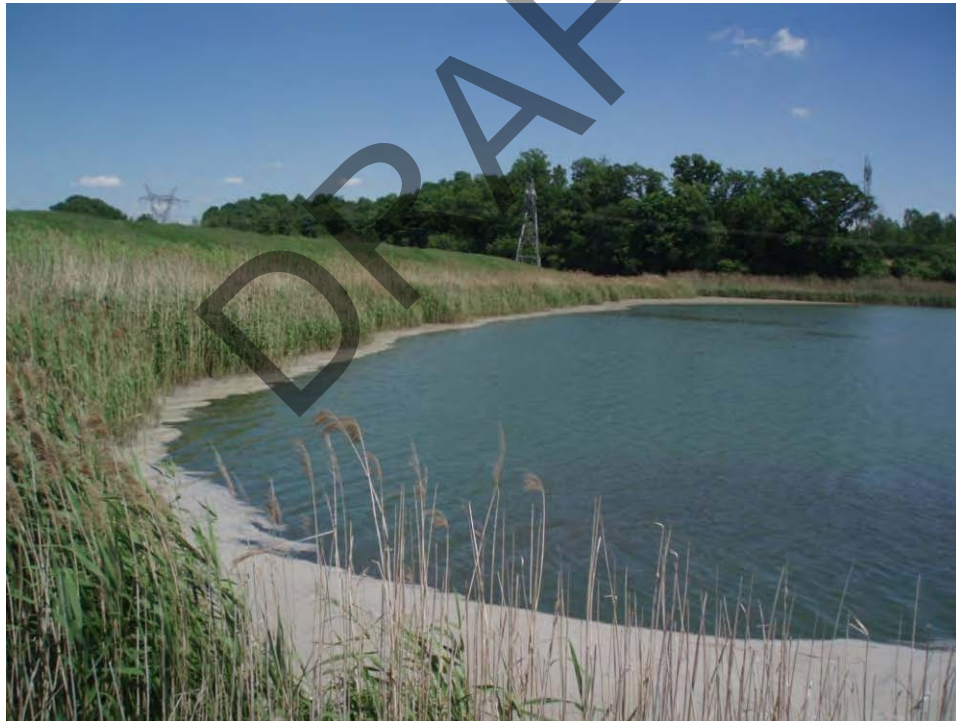
48. Overview of Pond A north interior slope, looking northeast.

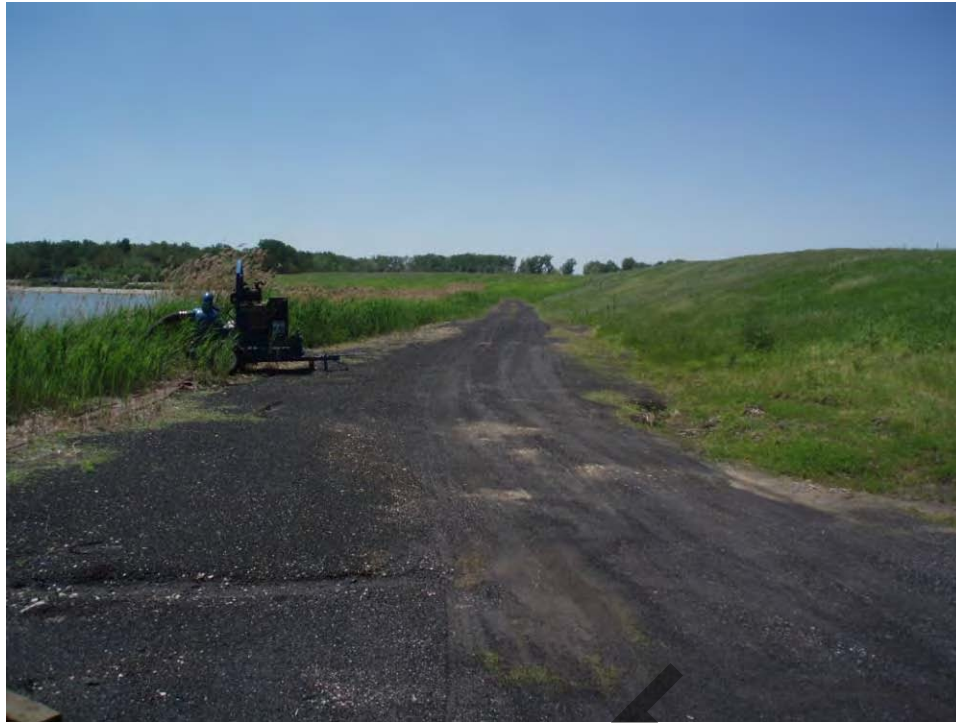
49. Pond A – North embankment crest and Pond B – South embankment exterior slope, looking west.

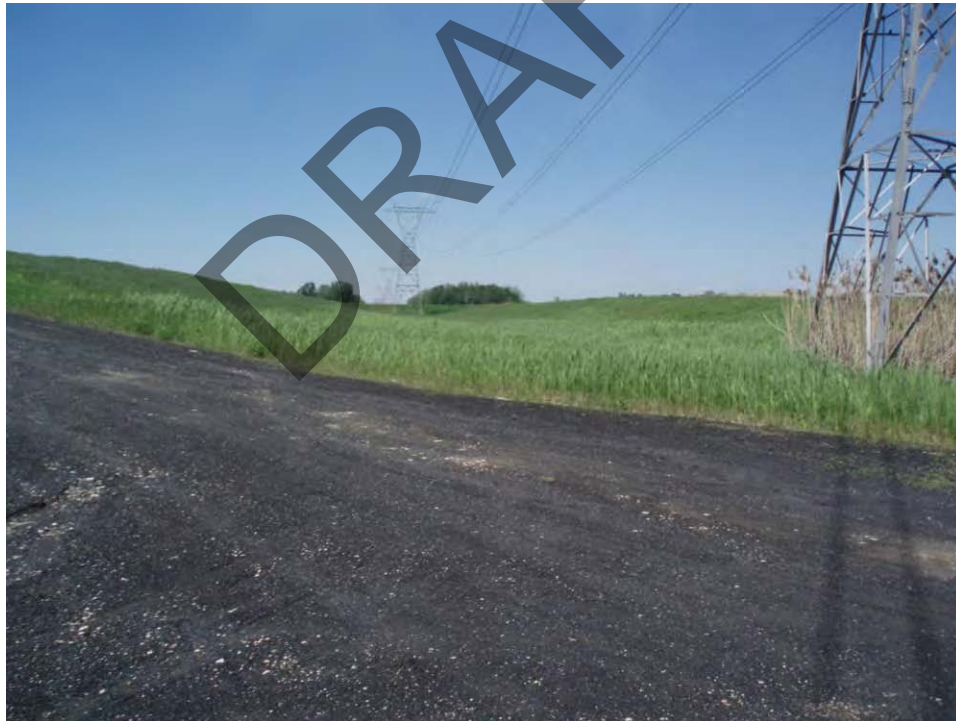
50. Pond B – North embankment exterior slope, looking northwest between Pond B and Pond C.

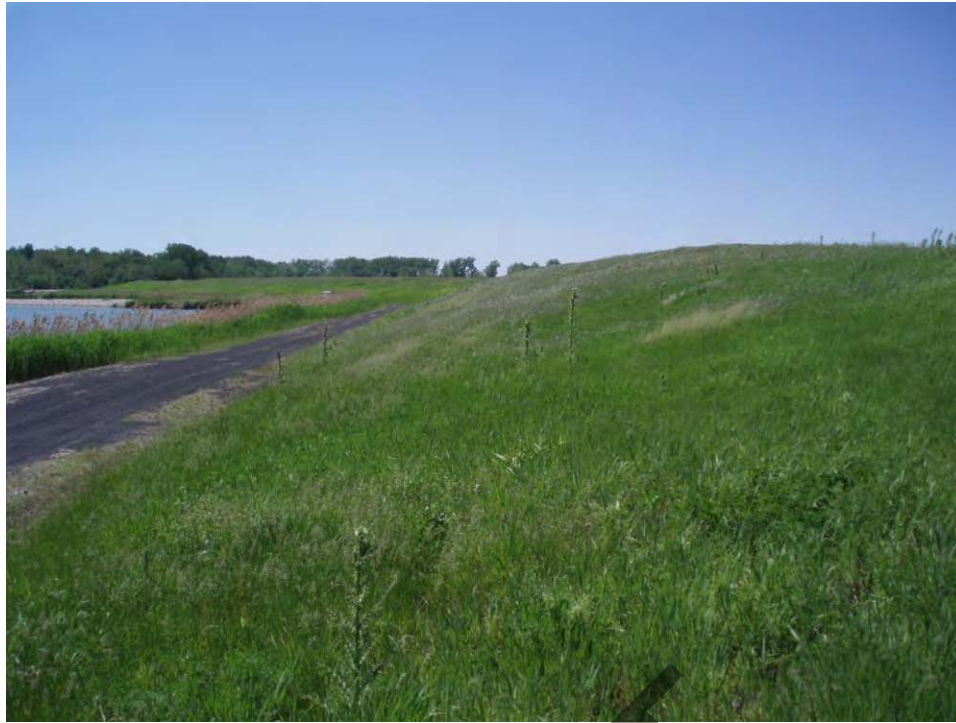
51. Pond B – South embankment exterior slope, looking west.

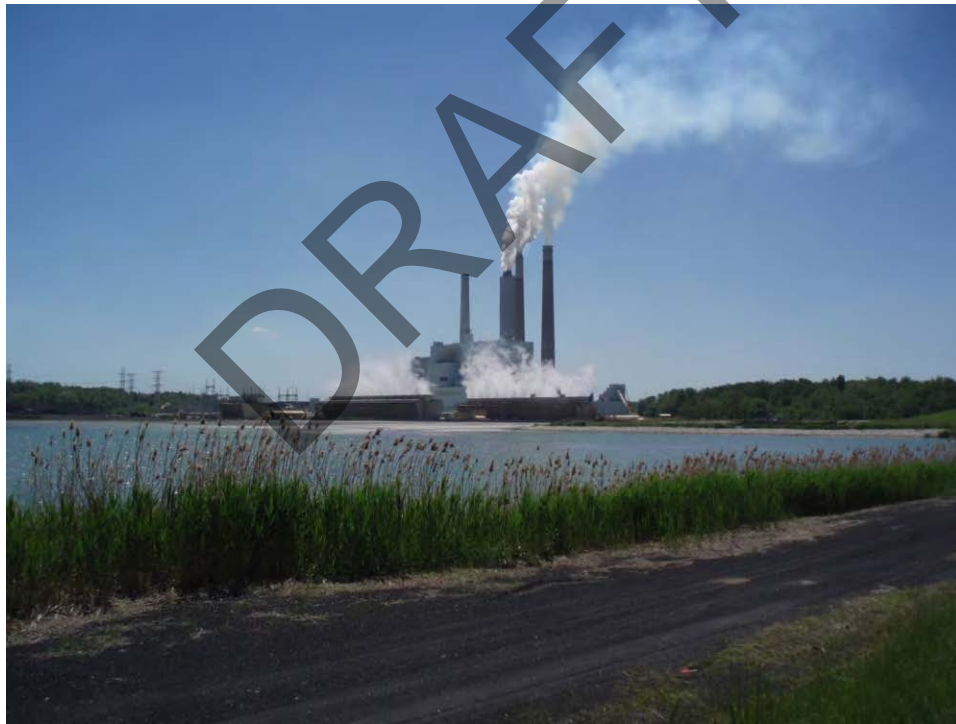
52. Overview of Pond A, looking southwest at Petersburg Generating Station.

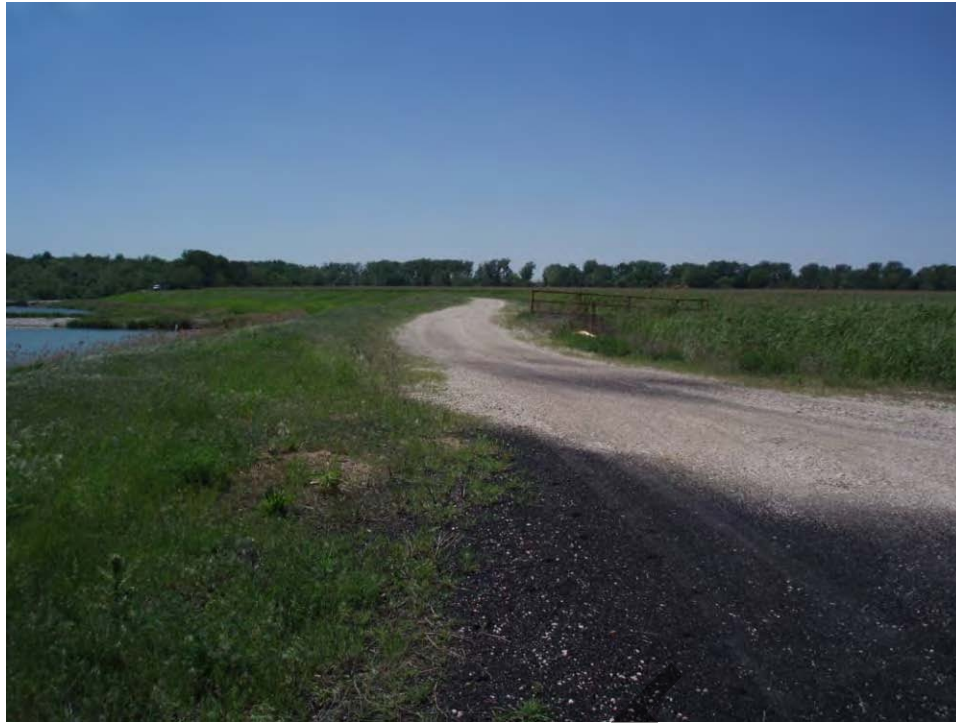
53. Pond B – South embankment crest, looking west.

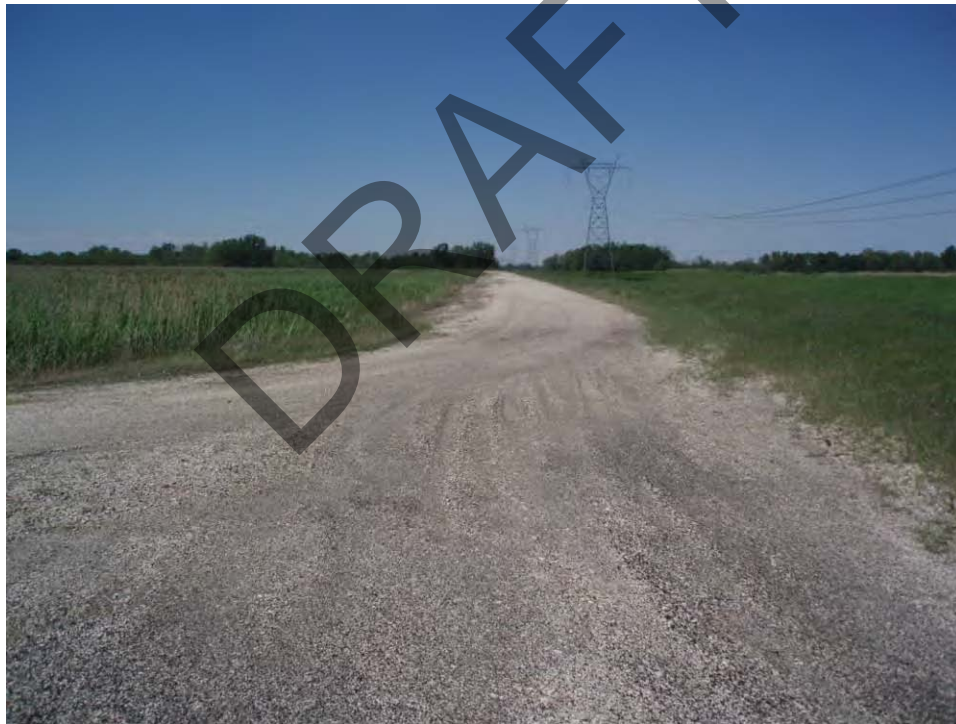
54. Pond B – East embankment crest, looking north.

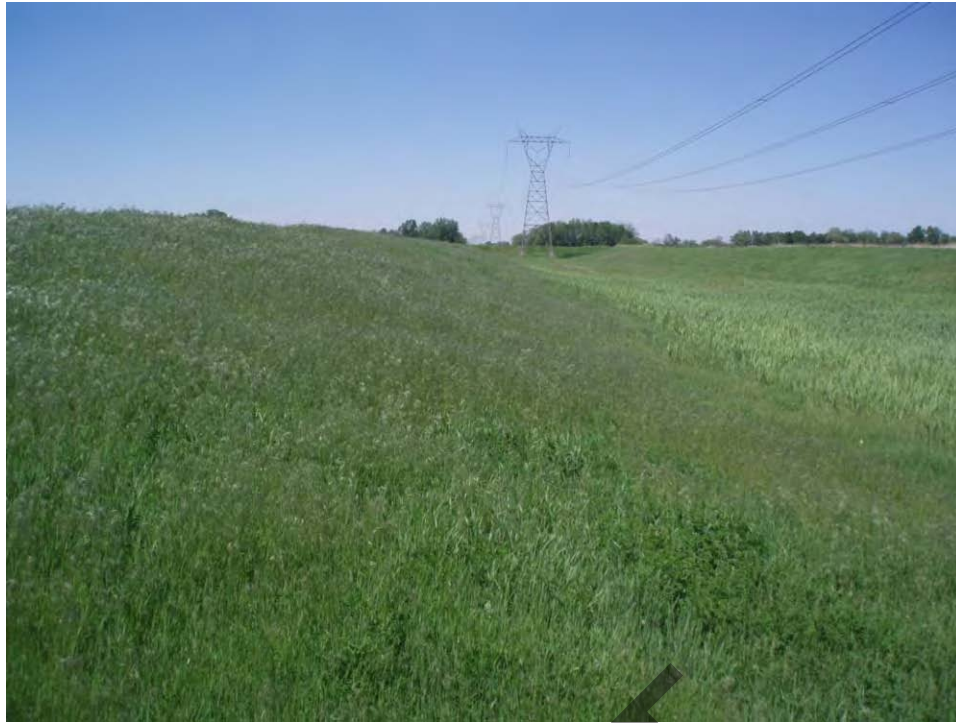
55. Pond B – East embankment exterior slope, looking north.

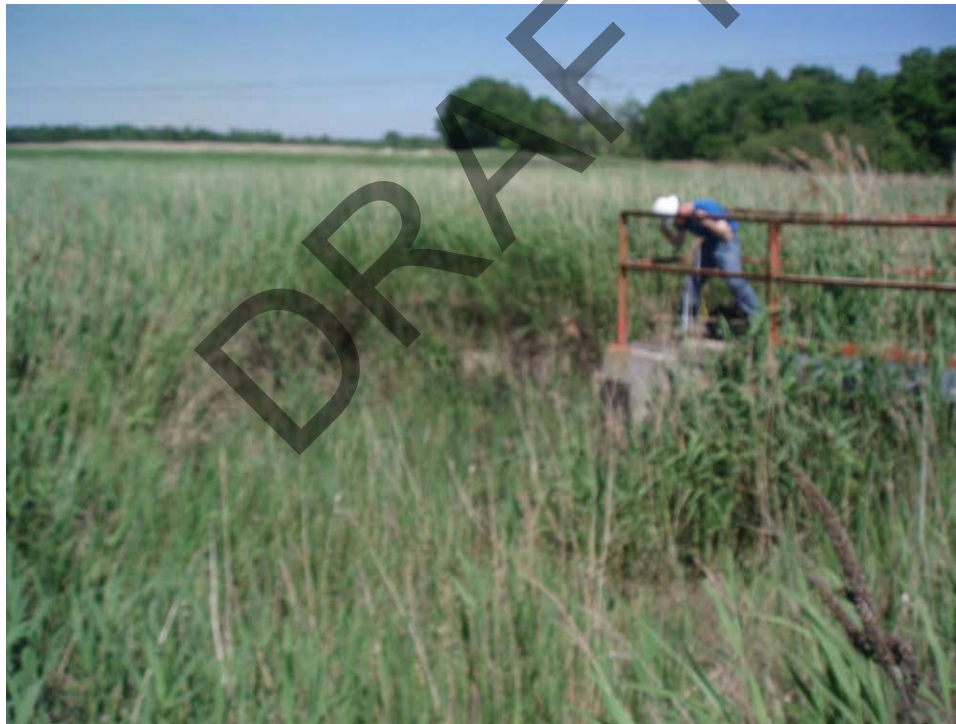
56. Pond B – Overview of outlet control structure with stoplogs, looking east.

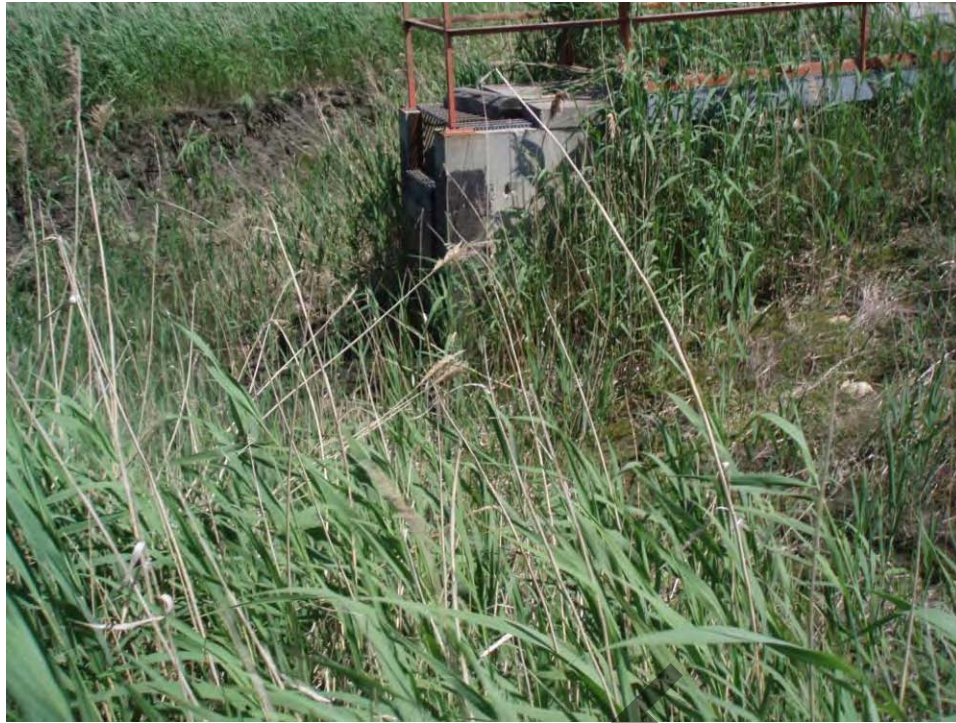
57. Pond B - Overview of outlet control structure with stoplogs, looking east.

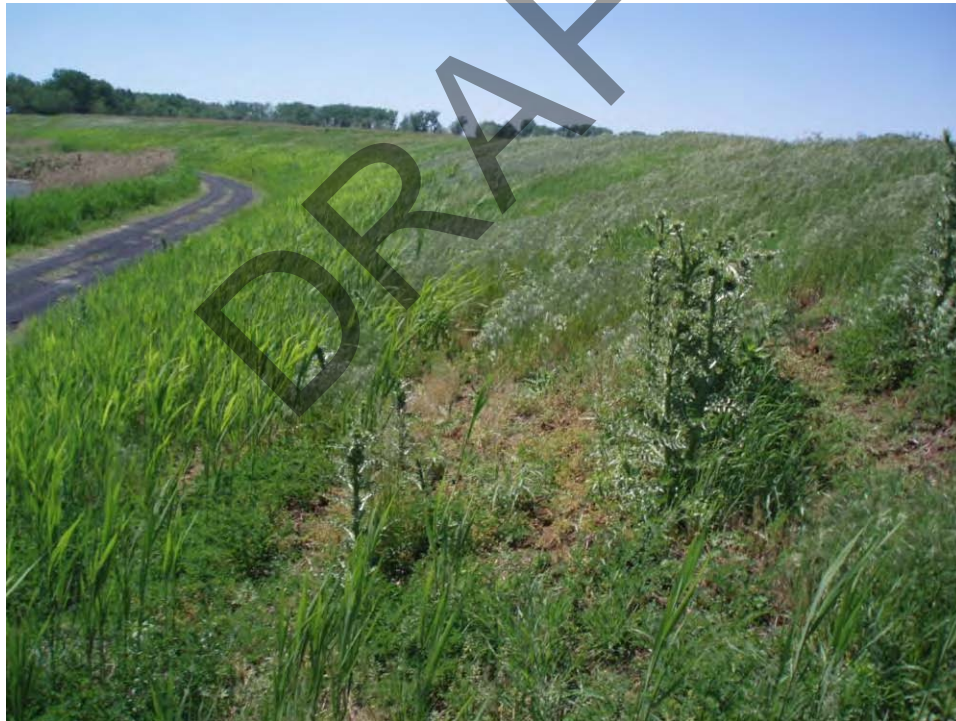
58. Pond B - South embankment exterior slope, looking west at tractor rutting and minor surficial erosion. Note change in vegetation at mid slope and stabilized FGD material very soft.

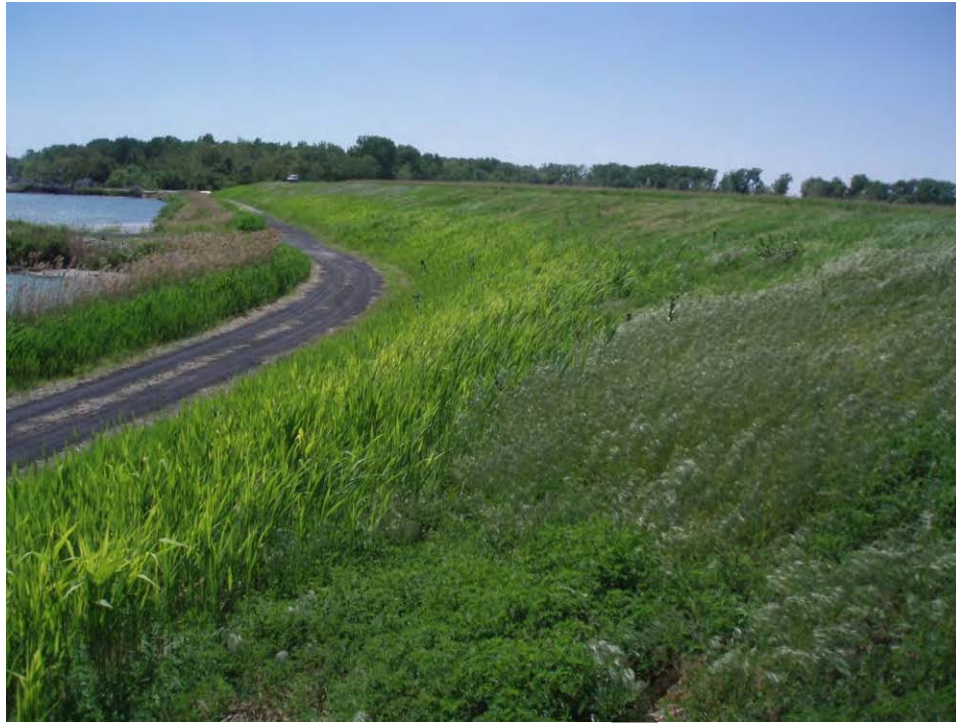
59. Pond B - South embankment exterior slope, looking west. Note change in vegetation at mid slope and stabilized FGD material is very soft.

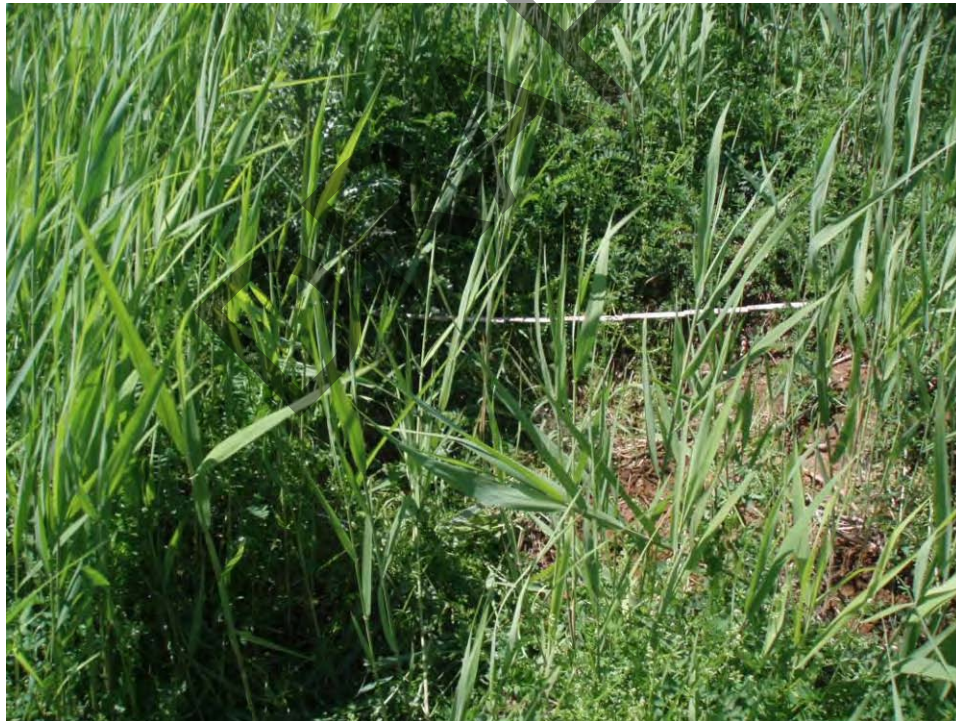
60. Pond B - South embankment exterior slope, looking north at 4'Wx1'D erosion feature.

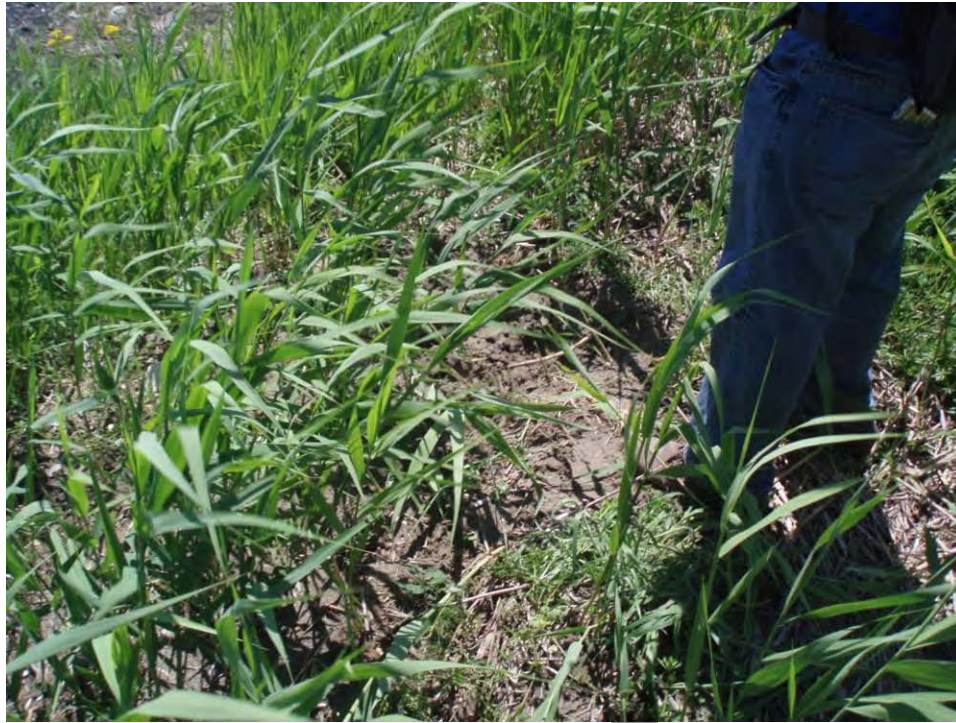
61. Pond B – South embankment exterior slope looking at bare spots of very soft, fine grained stabilized FGD.

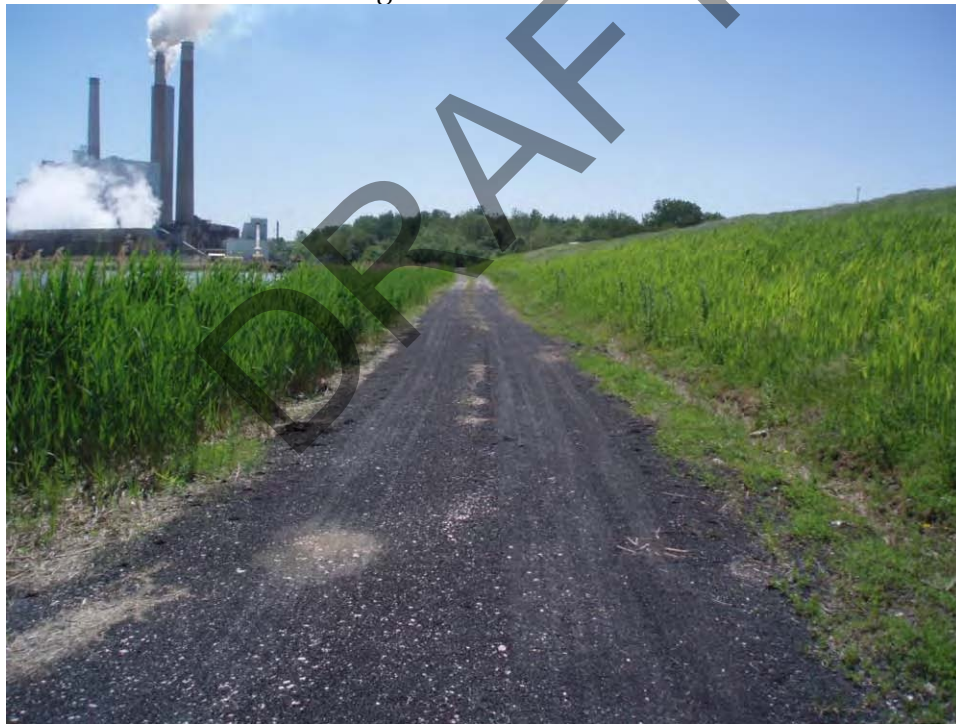
62. Pond A – Discharge north crest and Pond B south embankment toe, looking west.

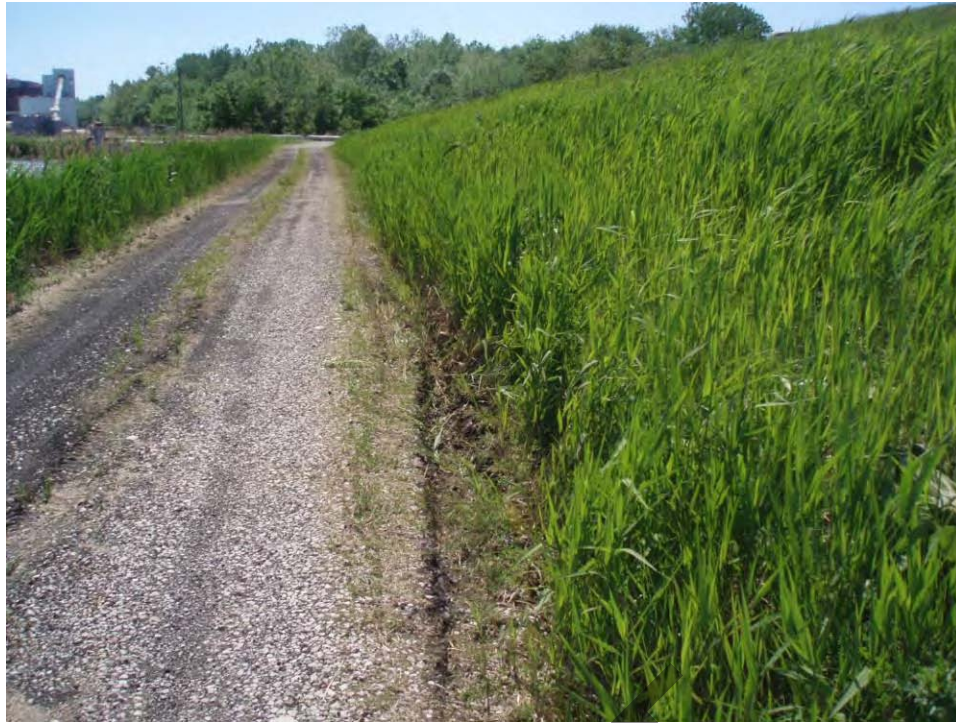
63. Pond B – South embankment exterior slope, looking southwest at possible seepage at toe.

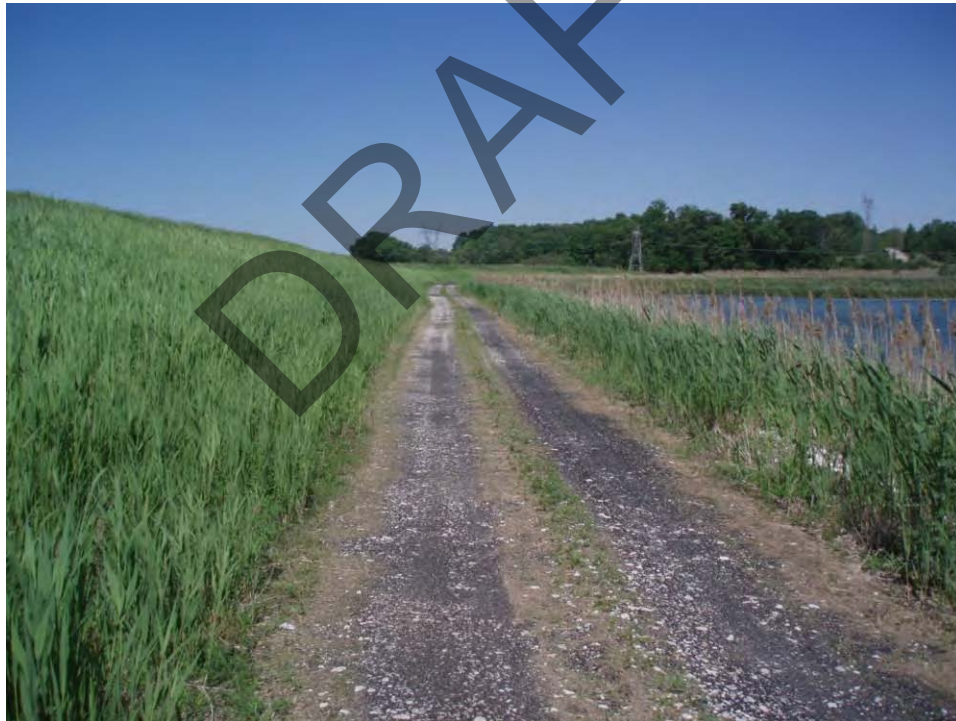
64. Pond A – Discharge north embankment crest and Pond B south embankment toe, looking northeast.

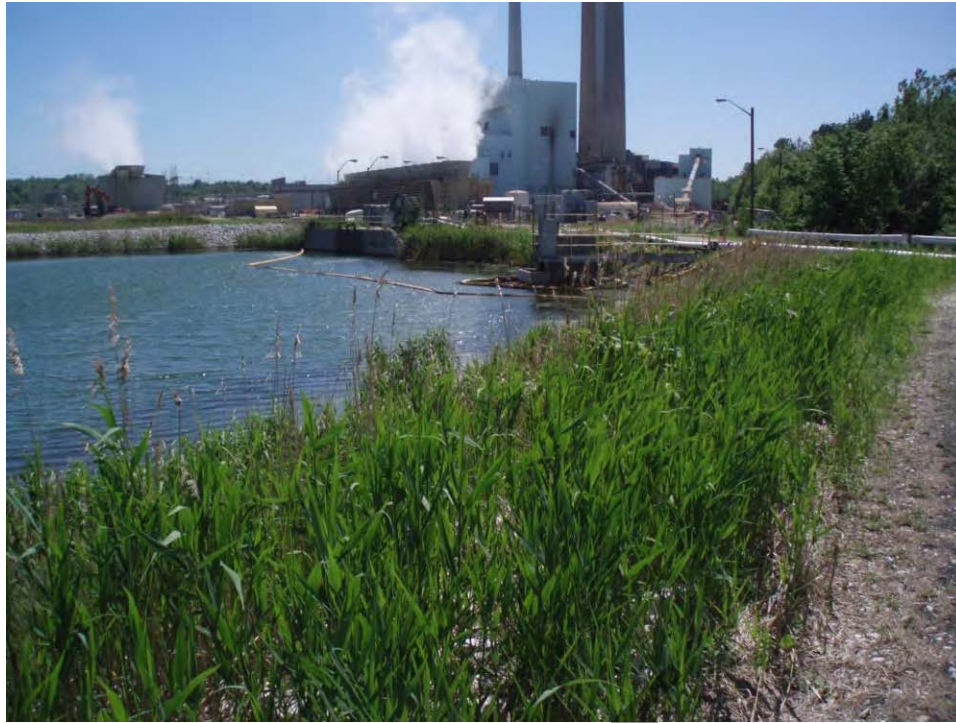
65. Pond A – Discharge, looking southwest at outlet structure and recycle pump station.

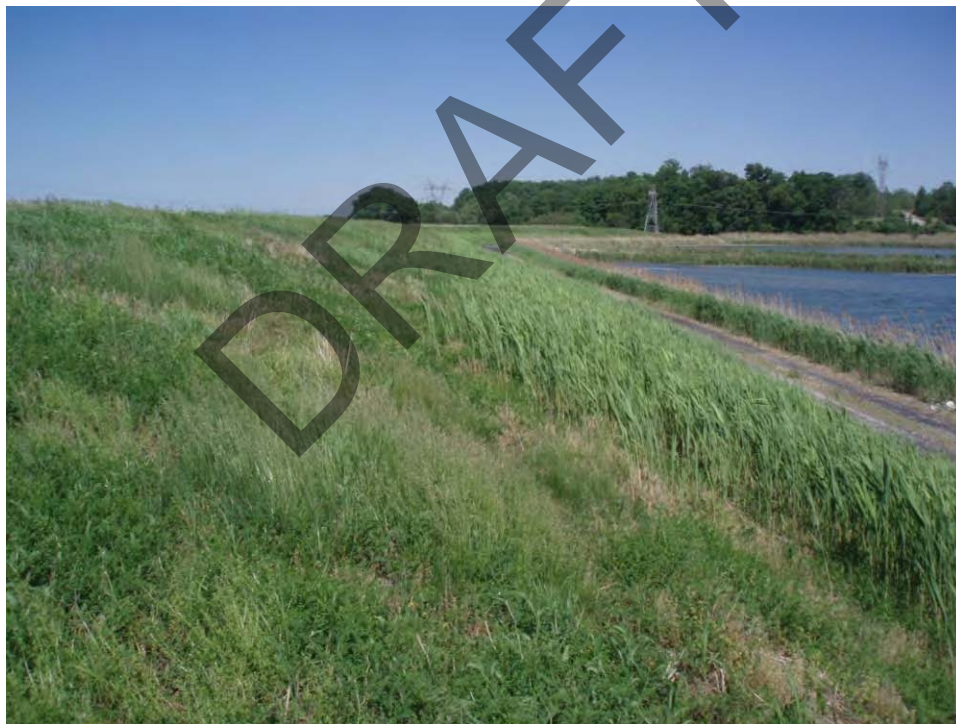
66. Pond B – South embankment exterior slope, looking northeast.

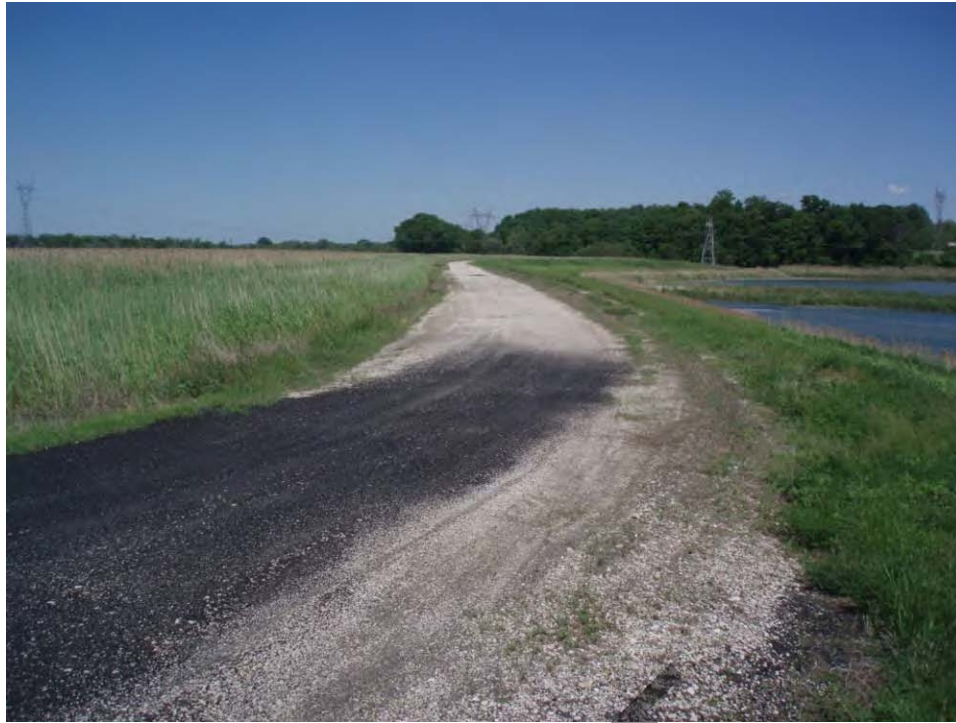
67. Pond B – South embankment crest, looking northeast.

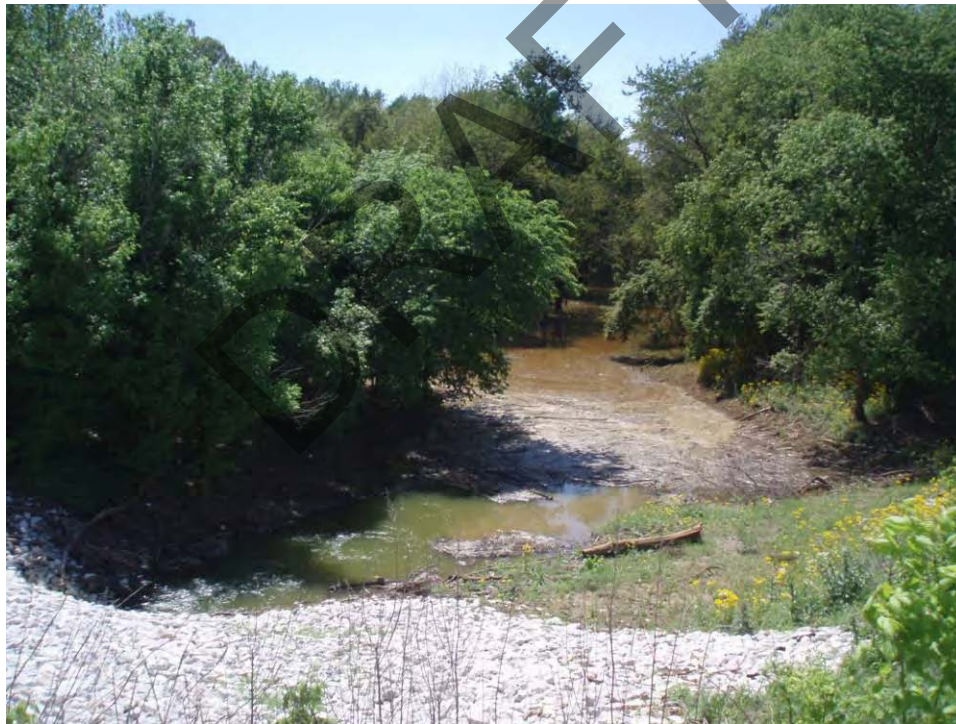
68. Pond A – Discharge, looking west at discharge canal to the White River.

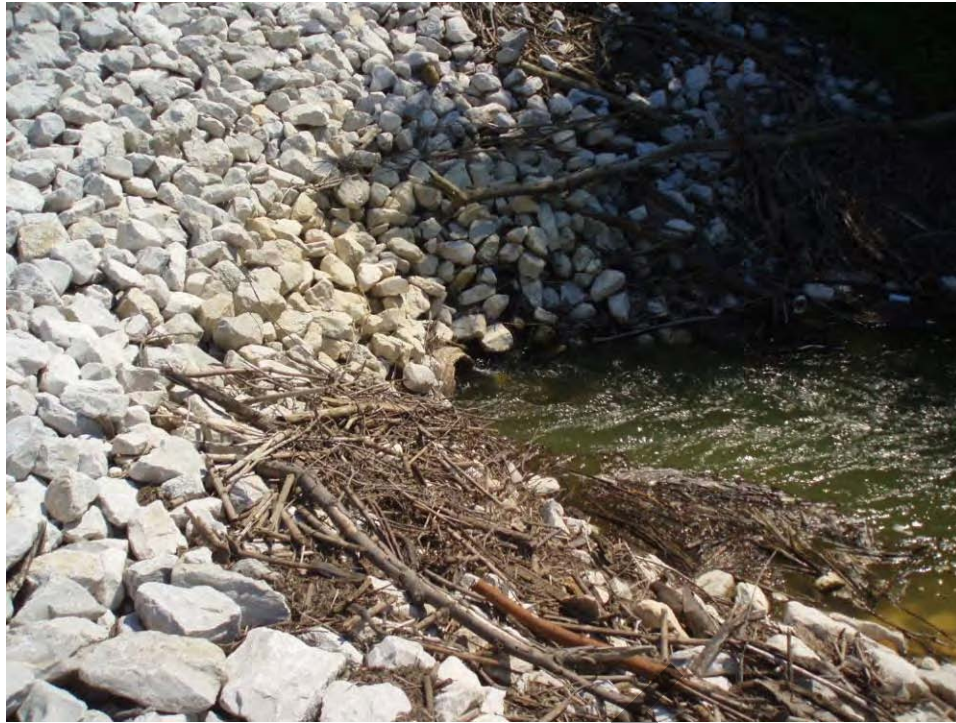
69. Pond A - Discharge, looking south at 24-inch-diameter RCP outlet pipe.

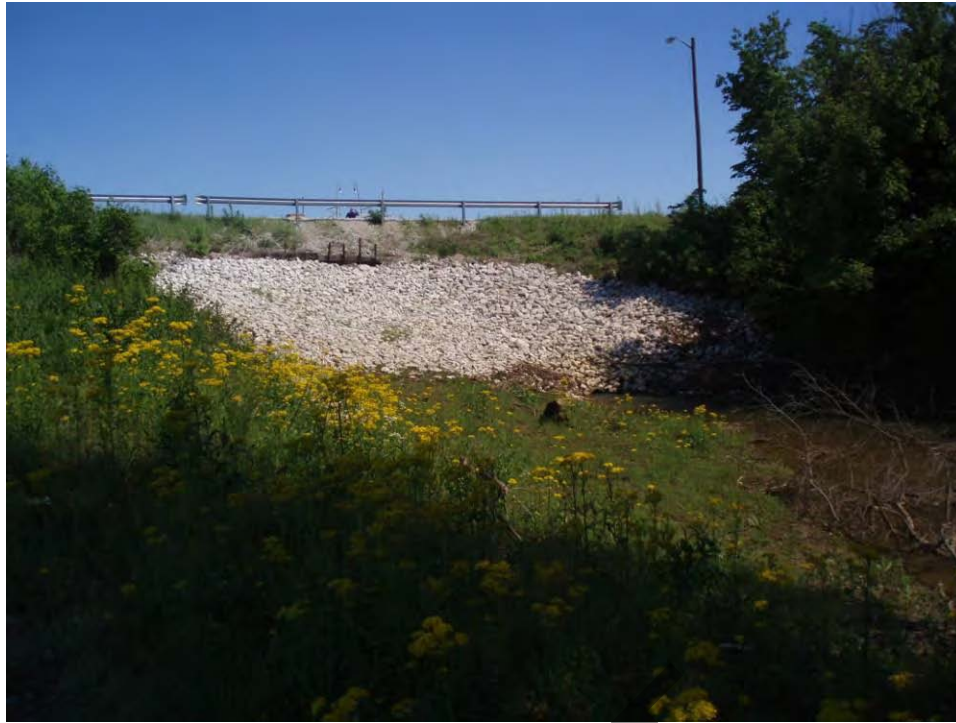
71. Pond A – Discharge, overview of downstream area from outfall.

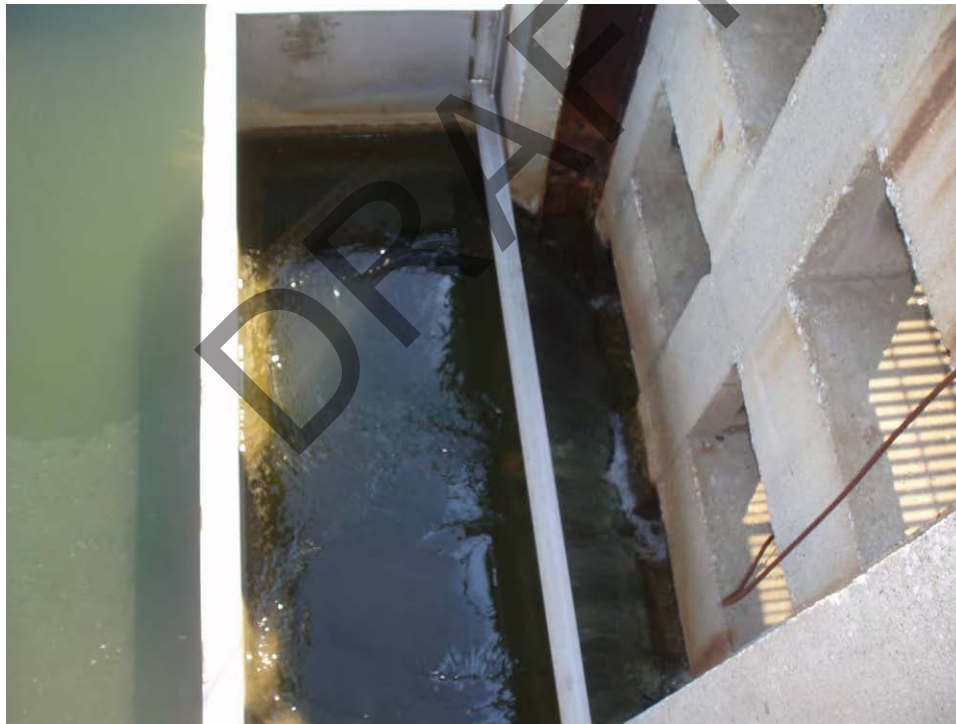
72. Pond A – Discharge, looking south at inlet to outlet control structure.

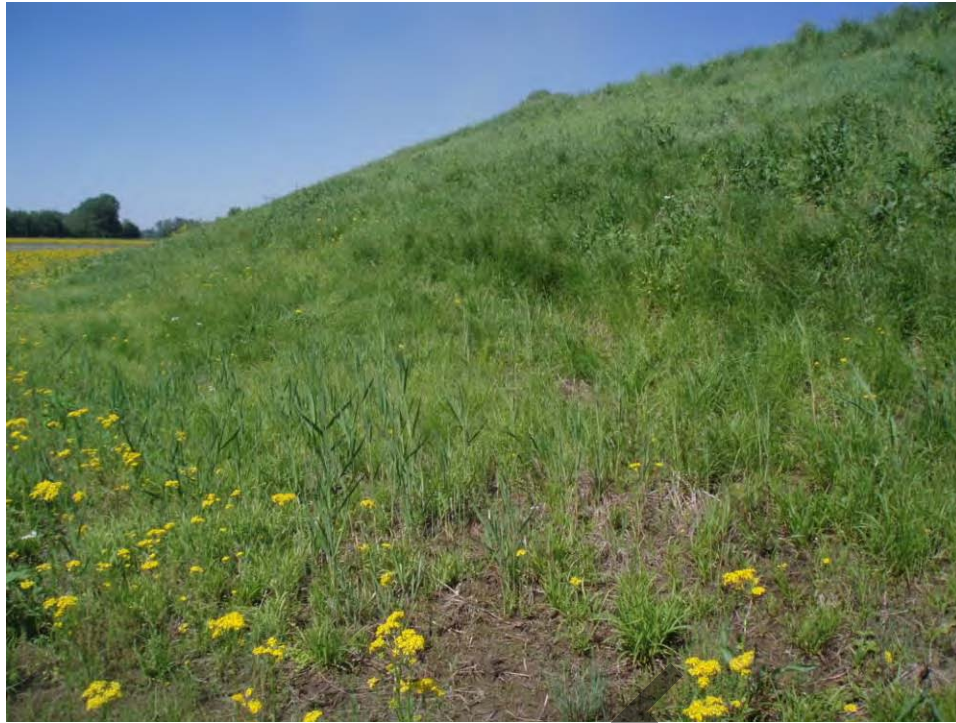
73. Pond B – West embankment lower exterior slope, looking north at saturated area at toe of slope.

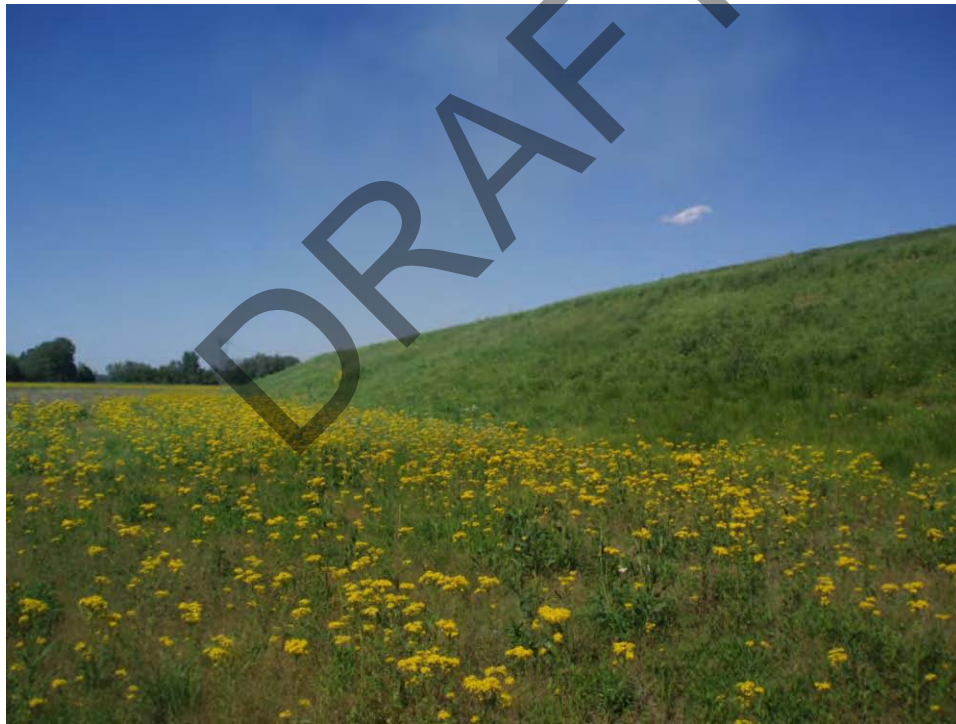
74. Pond B – West embankment, looking north at downstream area in flood plain. Note field area is saturated and wet from recent storm events.
